**EESTI MAAÜLIKOOL**  
**ESTONIAN UNIVERSITY OF LIFE SCIENCES**

**CONDITION AND RESIDUAL BEARING CAPACITY  
OF EXISTING REINFORCED CONCRETE  
STRUCTURES**

**MIHKEL KIVISTE**

A Thesis  
for applying for the degree of Doctor of Philosophy  
in Rural Building

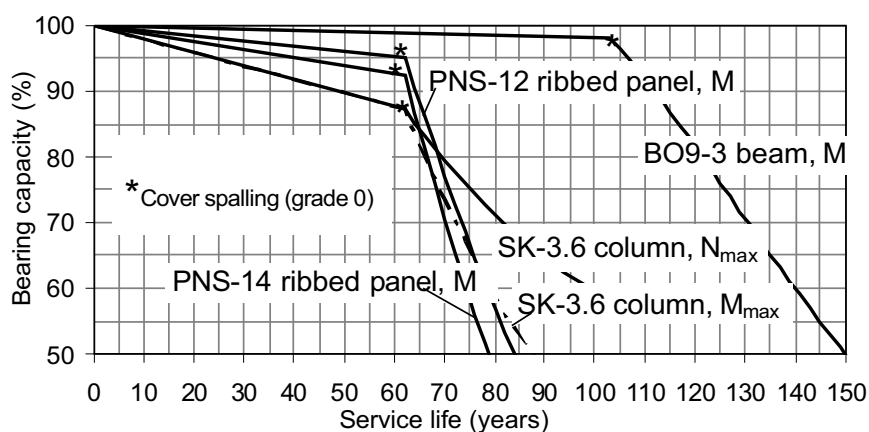
**Fig. 1.1.** A hypothetical model describing the decrease of the bearing capacity of common precast concrete structures in agricultural buildings (Laiakask and Miljan 2002, **III**). After cover spalling a corrosion rate of  $125 \mu\text{m}$  per year is assumed (Ostrovsky 1984).

A hypothetical model describing the reduction of the bearing capacity of common precast concrete structures in the agricultural buildings of Estonia was presented in **Fig. 1.1**. A common model for a reinforced concrete structure exposed to a corrosive environment was proposed by Torres-Acosta *et al.* (2007) in **Fig. 1.4**. The durability of a reinforced concrete structure is considered to be a three-phase process. The lifetime,  $T$ , of the structure, is defined as:

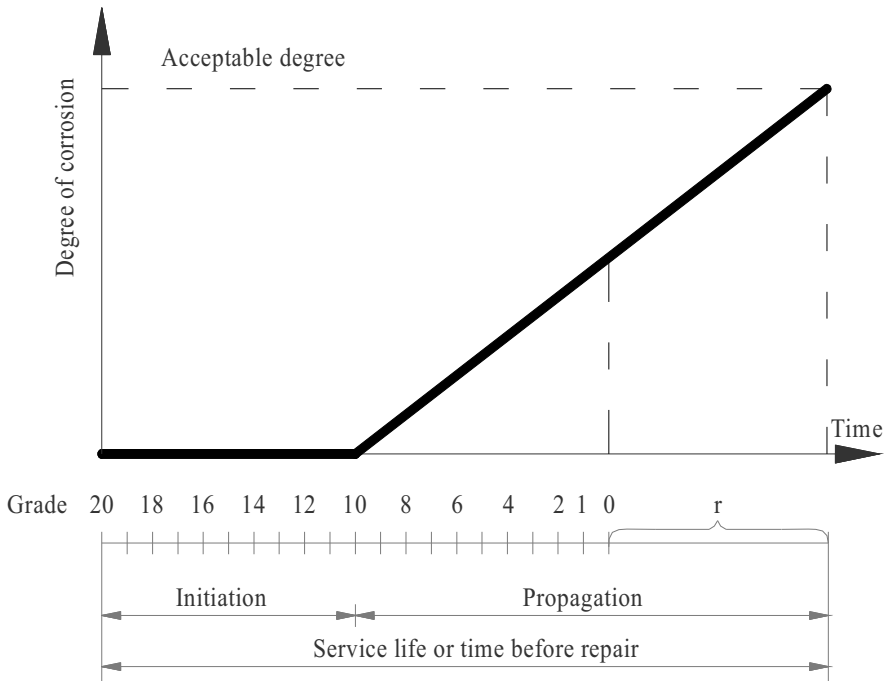
**Fig. 1.2.** Service life model for reinforcement corrosion (Tuutti 1982; Miljan 1977; Oit and Ojamaa 1974; **III**).

The most well-known service life model for reinforcement corrosion in concrete is published by Tuutti (1982; **Fig. 1.2**). From his work it is understood that the service life of a reinforced concrete structure may be divided into following two stages: an initiation period and propagation period. The initiation period comprises the time taken by an aggressive (chlorides or carbonation) to reach and depassivate reinforcing steel. The propagation stage is reached when steel starts to corrode and corrosion products cause cracking and spalling. Eventually a situation is reached,

Grades from 20 to 11 in the internal assessment scale (**Table 1.2**) are comprised in the initiation period, as shown in **Fig. 1.2**. Grade 10 equals to the depassivation period and grades 9 to 0 are a part of the propagation period. Further investigations are required to specify the length of period 'r' (**Fig. 1.2**) from grade 0 to the end of the service life.

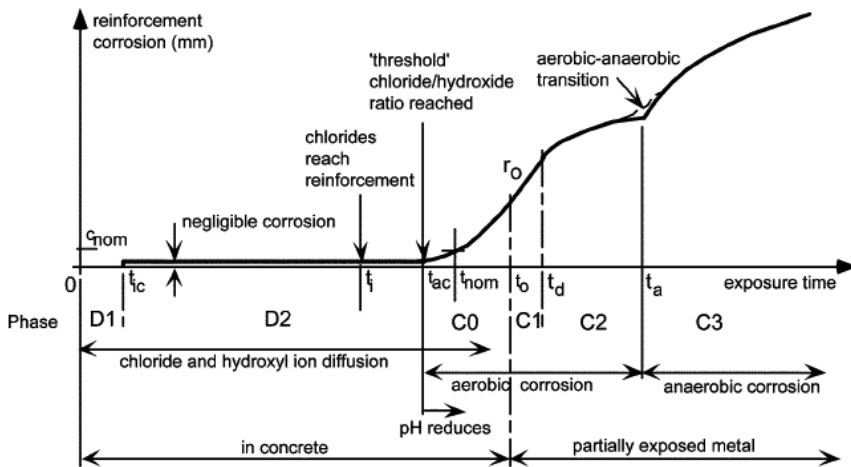
**Fig. 1.3.** Phenomenological model for chloride-induced steel corrosion in concrete (Li *et al.* 2008). *Diameter loss in mm.*

As shown in **Fig. 1.3**, Phase D1 is the diffusion of chlorides into the concrete and the commencement of hydroxyl ions leaching out of the concrete. When there are cracks present in the member (for example, flexural members), the local time to initiation  $t_{ic}$  is governed by the time of occurrence of the local crack(s) (Li 2002). When no cracks occur in the member,  $t_{ic}$  tends to be the initiation time  $t_i$ , which is governed by the rate of diffusion and therefore the permeability of the concrete (Melchers and Li 2006). At  $t_i$ , the chlorides have reached the steel but the balance

between the concentrations of the  $\text{Cl}^-$  and  $(\text{OH})^-$  ions and the pH may not be such that active corrosion will commence (which is denoted as  $t_{ac}$ ). During phase C0, the rate of corrosion tends to increase because the pH will typically reduce due to the hydroxyl ions leaching out of the concrete. In phase C1, the propagation of corrosion is governed by the rate of oxygen and water supplies and the conditions on the steel corroding surface. Because of micro-cracking (for example, caused by stress) and the resulting loss of influence from  $\text{Cl}^-$  and  $(\text{OH})^-$  ions and the greater permeability, the environment external to the concrete will increasingly control the corrosion rate. As corrosion progresses, there will be an increasing build-up of corrosion products and associated increased radial stresses, causing longitudinal cracking and, eventually, concrete cover spalling. Moreover, the increasing build-up of corrosion products on the corroding surfaces will contribute to an increasing resistance to oxygen diffusion (that is, the rate of oxygen supply to the corroding surfaces). Phase C2 denotes the period when this controls the rate of corrosion. Eventually, the rate of oxygen diffusion to the corroding bars through the rust layer will become so low that anaerobic corrosion activity will set in (Melchers 2003). This is shown as phase C3 in **Fig. 1.3**.

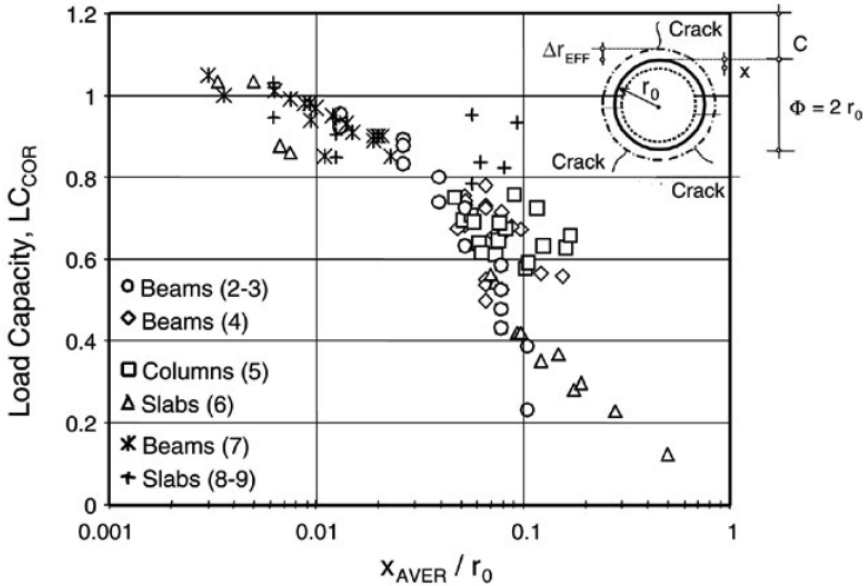
**Fig. 1.5.**  $LC_{\text{COR}}$  vs.  $x_{\text{AVER}}/r_0$  experimental results (Torres-Acosta *et al.* 2007). Based on the results of: 2—Mangat and Elgarf (1999a); 3—Mangat and Elgarf (1999b); 4—Rodriguez *et al.* (1997); 5—Rodriguez *et al.* (1996); 6—Almusallam *et al.* (1997); 7—Almusallam *et al.* (1996); 8—Huang and Yang (1997); 9—Tachibana *et al.* (1990).

**Fig. 1.5** presents a summary of the results of such investigations (Tachibana *et al.* 1990; Almusallam *et al.* 1996; Rodriguez *et al.* 1996; Almusallam *et al.* 1997; Huang and Yang 1997; Rodriguez *et al.* 1997; Mangat and Elgarf 1999a; Mangat and Elgarf 1999b); where different structural members (beams, columns, slabs) were corroded and tested up to failure. The horizontal axis in **Fig. 1.5** represents the corrosion-induced rebar radius loss, which is presented as a ratio between the average

Most of the studies (including the studies in **Fig. 1.5**) reporting structural tests on corroded reinforced concrete members have been conducted under laboratory conditions. Valuable data is available from flexural bearing capacity tests of reinforced concrete beams, where the steel corrosion rate is enhanced by applying an external impressed current (Azad *et al.* 2007; Du *et al.* 2007; Mangat and Elgarf 1999a; Huang and Yang 1997). In addition to electric current, reinforced concrete beams are cast with chlorides to initiate pitting corrosion (Torres-Acosta *et al.* 2007; Rodriguez *et al.* 1997). The combined effect of corrosion

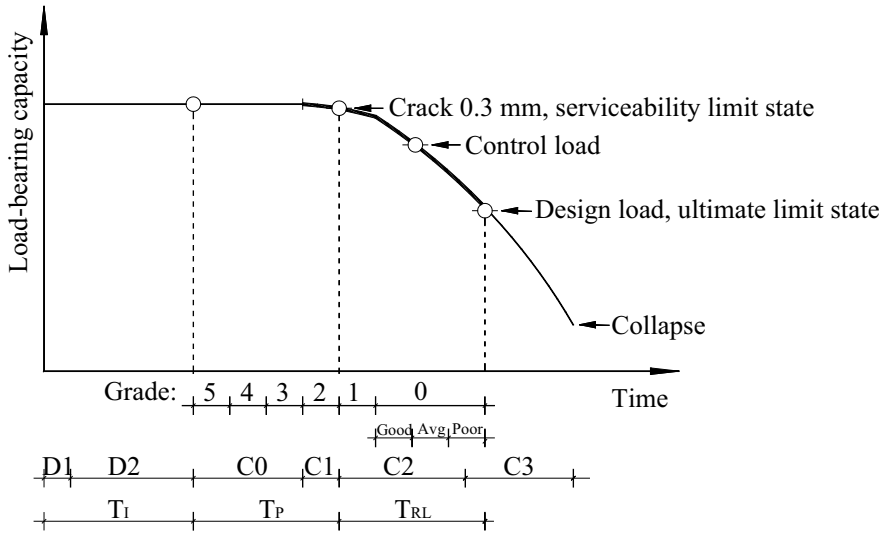
**Fig. 4.2.** An illustrative load-bearing capacity model for an RCM. Based on Torres-Acosta *et al.* (2007) and the current study with the addition of research results by Heymsfield *et al.* (2007); Li *et al.* (2008).

The categorisations of ‘good’, ‘average’ and ‘poor’ by Heymsfield *et al.* (2007) are also included in **Fig. 4.2**. An attempt has to be made to add the six detailed phases of the phenomenological model (Li *et al.* 2008) for steel corrosion in concrete. However, the model by Li *et al.* (2008) has a different approach. The latter differentiates six phases (D1, D2, C0, C1, C2, C3) of corrosion applied to the steel bar at a generic cross section of a reinforced concrete member. In addition, the initiation period of the model by Li *et al.* (2008) was based on corrosion induced by chloride attack.

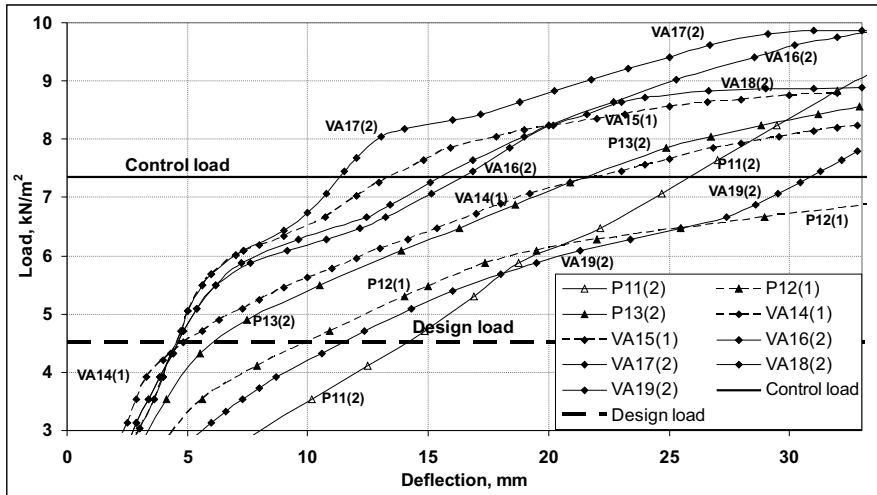
**Fig. 4.4.** Load-deflection curves of 9 prestressed concrete ribbed panels PNS-3.

**Fig. 4.3** shows that ribbed panels with a lower visual grade tend to have larger deflections at the same load. For example, at control load ribbed panel with grade 2 has deflected 6 mm, while ribbed panels with grades 1 (except of K-5) and 0 have deflected 8–10 mm and at least 17 mm, respectively. Ribbed panels K-3, K-6 and K-8 (with grade 0) deflected at least 40 mm at control load. This trend conforms to Azad *et al.* (2007), who found that the corroded beams had higher deflection than the corresponding control beams at the same load due to degrading stiffness. However, Azad *et al.* (2007) applied sodium chloride and a direct current to initiate and accelerate corrosion, respectively, which complicates the comparison with the current study. It should be noted that only a limited amount of ribbed panels of different grades are presented in **Figs. 4.3** and **4.4**. However, the statement that lower grade ribbed panels have larger deflections is not clear with ribbed panels PNS-3 in **Fig. 4.4**.

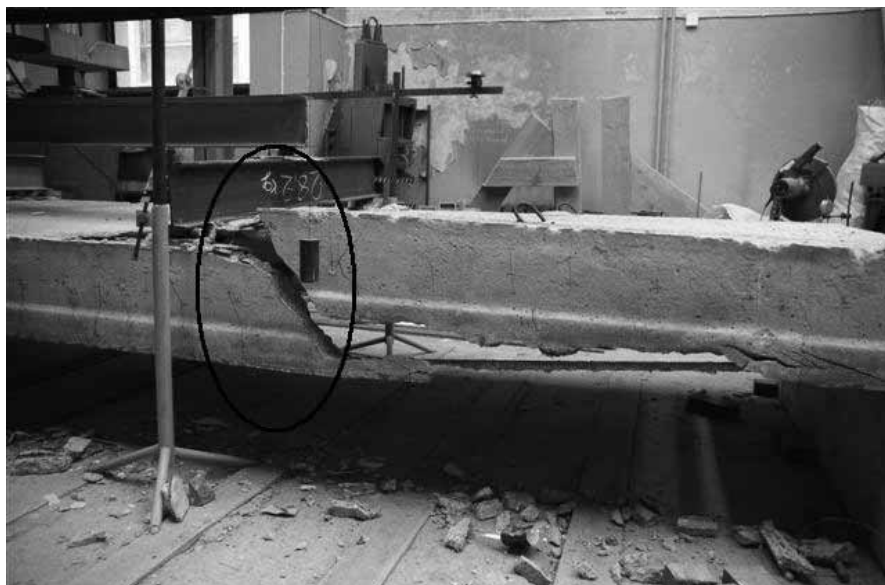
**Fig. 4.9.** Shear failure of ribbed panel V12.

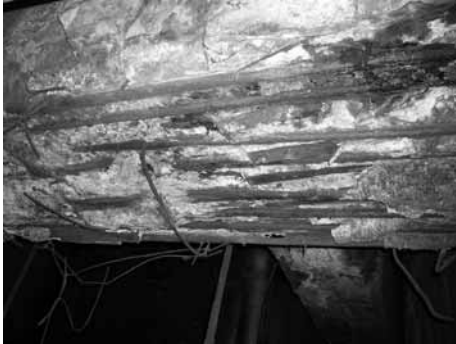
**Fig. 4.11.** Bottom view of a fragment of a girder carrying a generator on the 2nd floor.

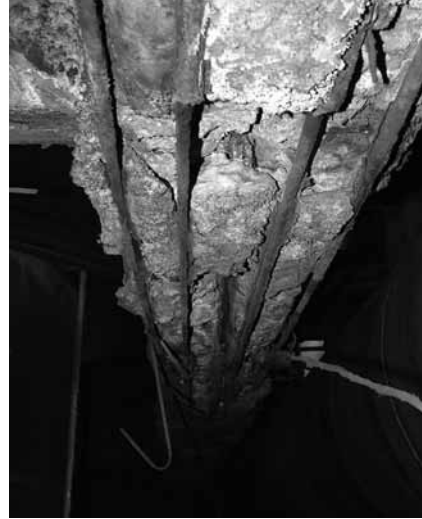
**Fig. 4.12.** Bottom view of a fragment of a joist carrying a generator on the 2nd floor.

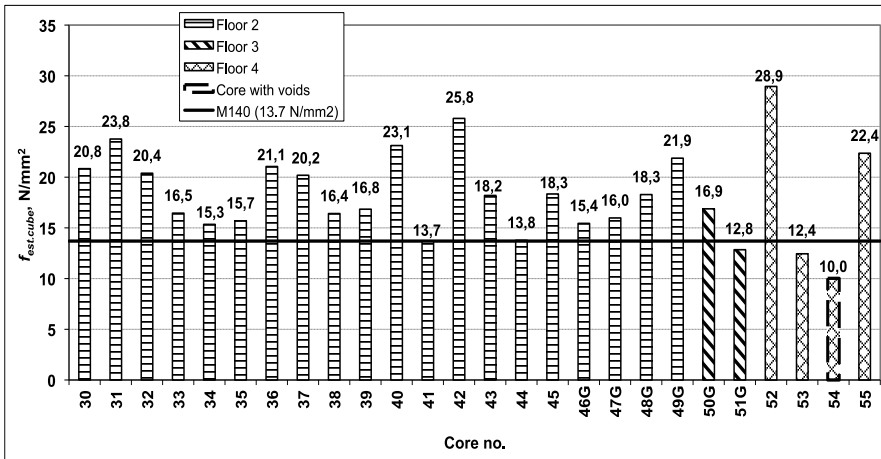
**Fig. 4.14.** Compressive strength of 26 cores drilled from beams. *G* behind core number denotes cores drilled from beam carrying generator.

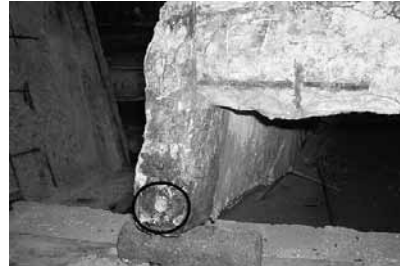
Fig. 4. The support of panel R7 after anchorage failure.

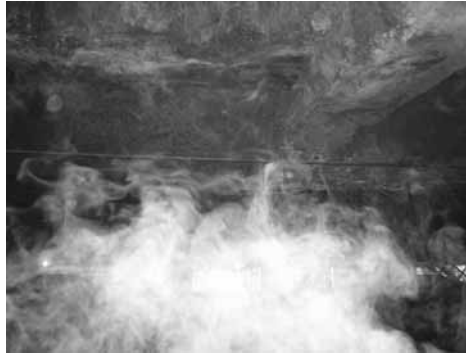
*Fig. 1.* Concrete structures exposed to the gases generated in water quenching of semicoke.

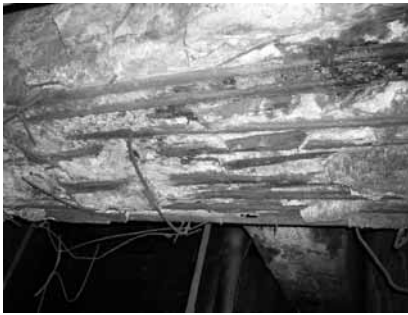
Fig. 2. Bottom view of a girder fragment carrying generator on the 2nd floor.

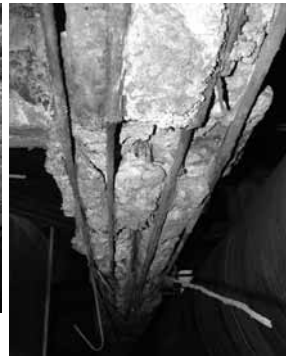
Fig. 3. Bottom view of a joist fragment carrying generator on the 2nd floor.

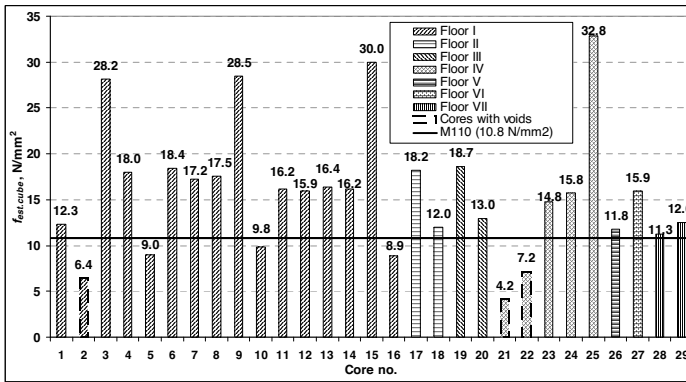
Fig. 4. Compressive strength of 29 cores drilled from columns.

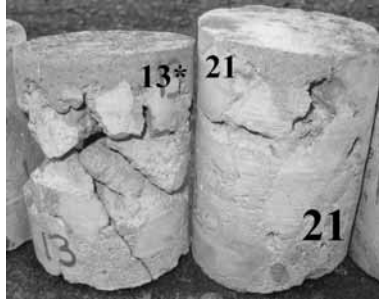
Fig. 6. Concrete cores 13\* and 21 after drilling from columns.

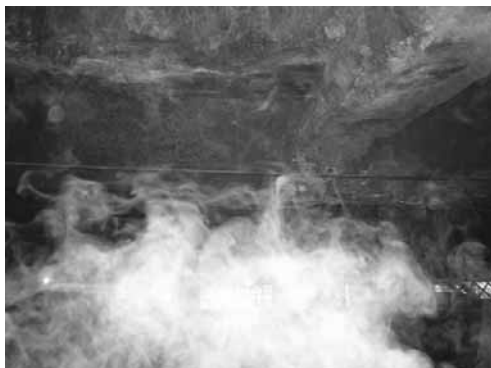
Figure 1. Mixture of gases produced with oil-shale water quenching

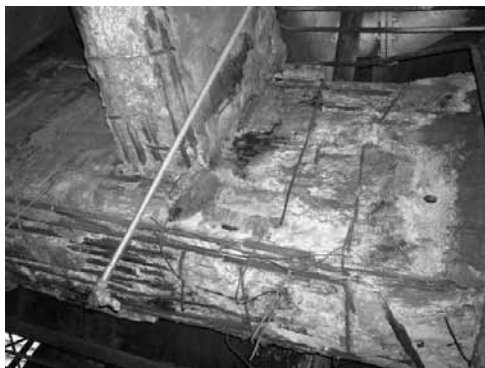
Figure 2. Condition of some concrete beams on the first floor
